Nondestructive Evaluation of a Metal Matrix Composite

ARL-TR-3118 December 2003

Army Research Laboratory

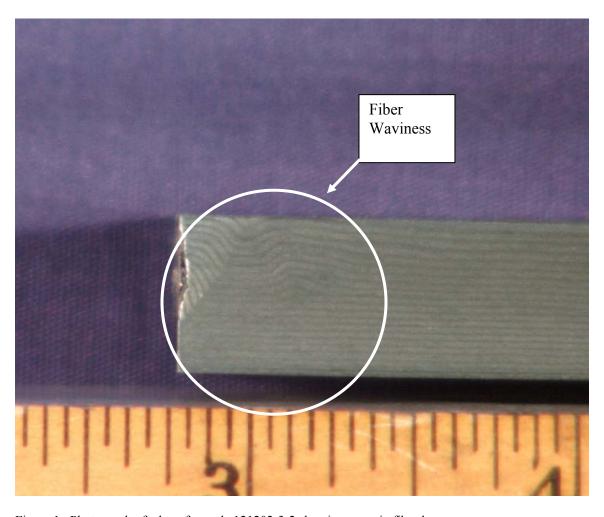
having carbon residue. The residue was left over after burning off the epoxy used to manufacture the fiber prepreg. The wave in sample 121202-3-2 was close to the end of the sample and consequently difficult to examine with ultrasonics. This wave is shown in figure 1.

Figure 1. Photograph of edge of sample 121202-3-2 showing wave in fiber layers.

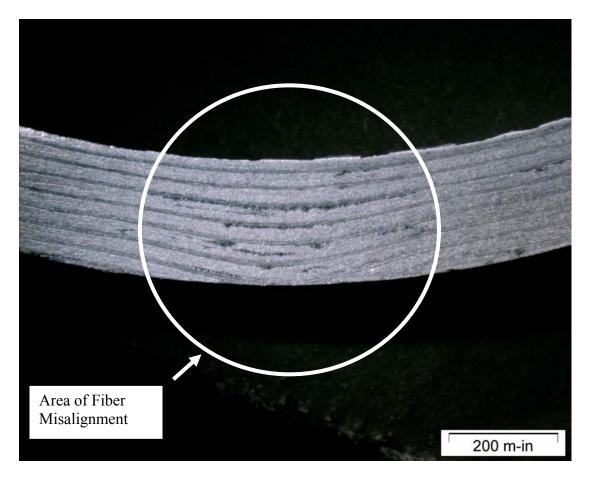
3MC1, is shown in figure 2. The dark striations are the longitudinal layers and the lighter bands are the hoop wraps. This sample was included in the NDE tests with the other samples.

Figure 2. Polished end of sample 3MC1 showing fiber misalignment.

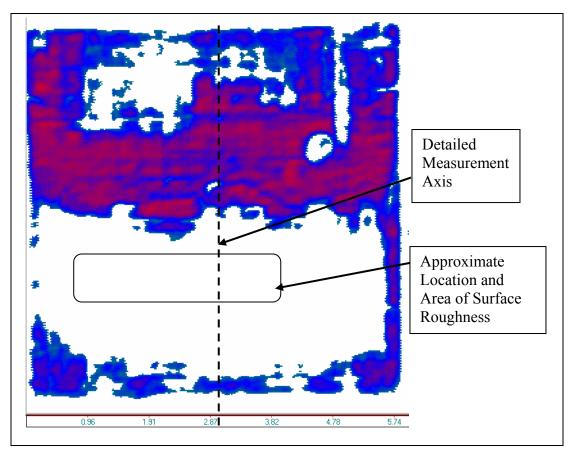
Figure 7. C-scan of sample 112202-1-2.

In this figure, the red indicates a strong return signal, the blue represents a weaker return, and the white indicates a very low return. Thus, there is a good possibility that some type of flaw is located in the white area. In fact, the surface roughness of this plate (even after machining) was an indication that the fibers had not been completely infused with aluminum. This area of surface roughness is shown in figure 8 as an overlay to the C-scan. It is considerably smaller than the total area shown by the C-scan to have a potential defect. The transition from the area indicated by blue on the C-scan to the white area was investigated in a more quantitative manner. Individual measurements of the sonic velocity and second peak amplitude were taken along the broken line shown in figure 7. The equation of this broken line would be x = 3 inches in a coordinate system where x = y = 0 is the bottom left-hand corner of the plate. A plot of the second peak amplitude vs. position along the measurement axis is shown in figure 8. There was virtually no signal (first peak amplitude) between y = 0.5 in and y = 2.8 in. The drop-off in signal going from y = 3.2 in to y = 2.9 in is almost as steep as that shown in figure 6, indicating an abrupt discontinuity in material properties.

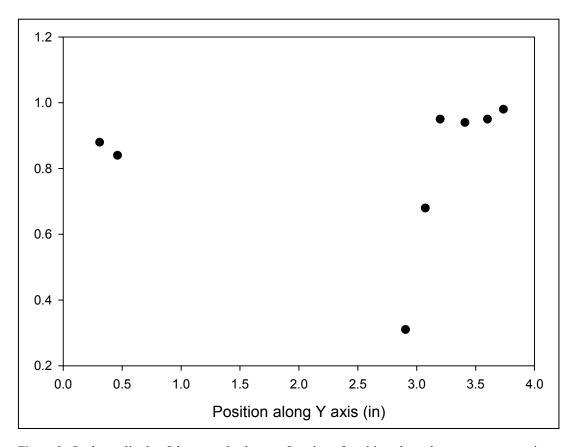
Figure 8. Peak amplitude of the second echo as a function of position along the measurement axis.

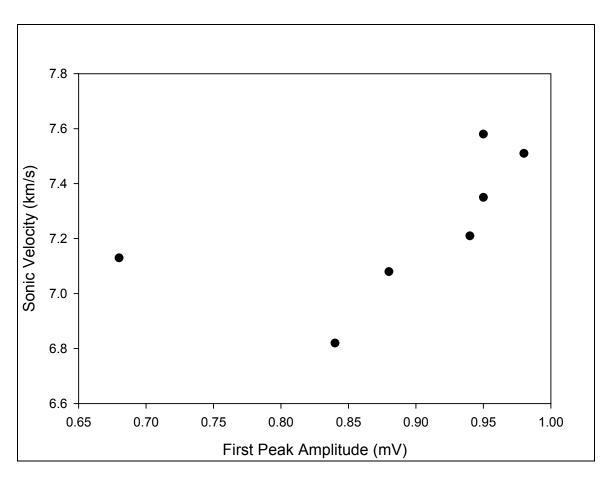
Except for the one outlying point, there appears to be a rough linear relation between the sonic velocity and peak amplitude. The low value of the amplitude for the outlier might be due to the surface roughness, dispersing the incident sonic wave and thus reducing the amplitude of subsequent echoes.

Figure 9. Sonic velocity vs. peak amplitude along the measurement axis.

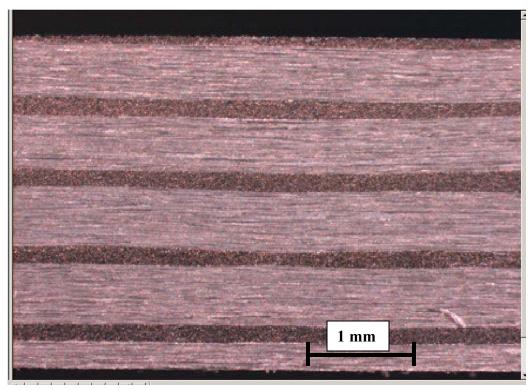
The plate was cut along the measurement axis to reveal the internal structure of the composite material. High-magnification photographs of two regions are contrasted in figures 10 and 11. In figure 10, the portion of the sample where the ultrasonics indicated a sound material is shown. This figure reveals alternating layers of fiber material with even spacing between layers. Figure 11 shows a small portion of the region where problems might be expected from the ultrasonic measurements. This photomicrograph in this figure appears to be slightly out of focus. This is due to the uneven nature of the polished surface. That is, there are portions of layers where only fibers are present with no aluminum matrix. In some areas fibers are missing, possibly removed during the polishing process. It is clear that this is the portion of the sample where there is a lack of infusion.

Figure 10. Photomicrograph of sound material portion of sample 112202-2-1 (through-thickness cross section).

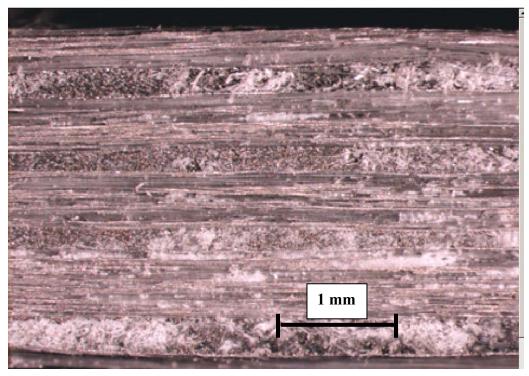
A visual examination with a low-power magnifying glass of the cut and polished surface revealed delaminations or lack of infusion from $\sim y = 0.5$ in to y = 2.75 in. This corresponds to the white region in the C-scan for this sample.

Figure 11. Photomicrograph of unsound portion of sample 112202-1-2.

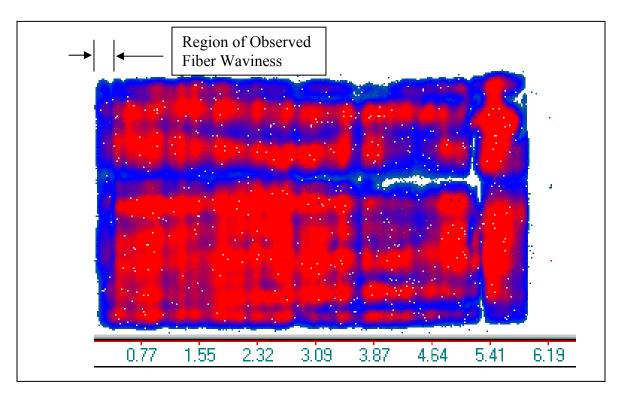
This figure shows the area where the fiber waviness is observed, extending $\sim 3/8$ in along the left edge of the sample (see also figure 1). While this portion of the C-scan has a somewhat weaker return signal than other portions of the sample, it certainly is strong enough to suggest there is no significant defect in that region. There also appears to be a more serious defect indicated by the white area in the middle right-hand portion of the sample. The sample was sectioned perpendicular to the long axis of the sample through a location that would reveal what sort of

Figure 12. C-scan of sample 121202-3-2 (fiber waviness).

defect was represented by the white area in the C-scan. However, no defect of any significance could be observed in this location.

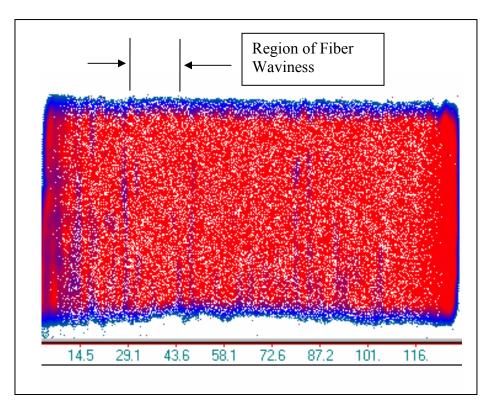
Figure 13. Carbon residue flaw.

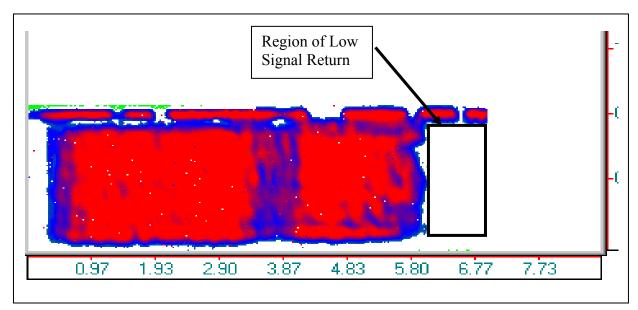
The next sample examined (110102-2-1) had carbon residue as a known flaw. It was not clear at the onset how this defect would appear on the C-scan. Its C-scan is shown in figure 14. The scale at the bottom of the figure is in inches. The sample length was over 7 in. However, most of the C-scan signal is missing from ~6 to 7 in. There is also a flaw indication in a line running along the top of the C-scan. This latter flaw is attributed to the machining groove cut in the surface of the sample.

Figure 14. C-scan of sample 110102-2-1 (carbon residue).

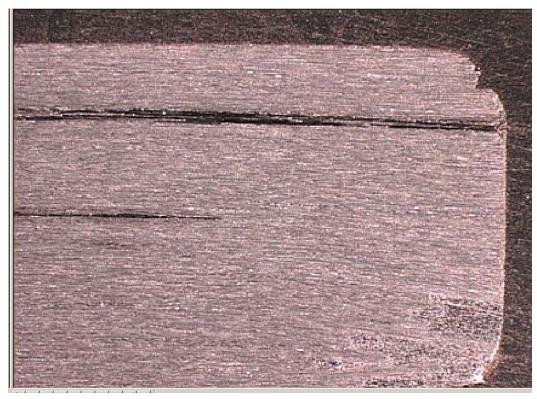
After polishing the edge of this sample, a closer look at the right-hand end revealed two cracks in separate planes extending about an inch into the sample from the right end. Figure 15 shows a photomicrograph of edge of this sample at the right-hand end.

Figure 15. Photomicrograph of edge of sample 110102-2-1.

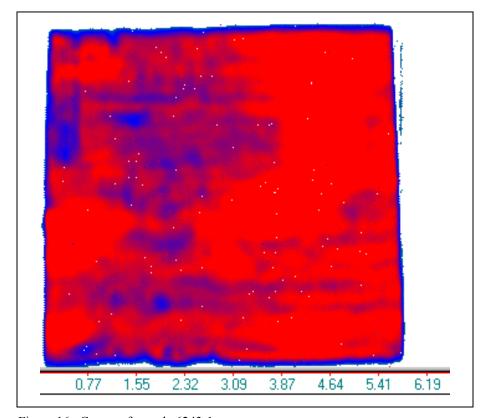
The final sample with a known defect, 6243-1, was scanned with the result shown in figure 16. Note that the horizontal scale (in inches) does not apply in the vertical direction. There was no indication of any major defect in this sample.

Figure 16. C-scan of sample 6243-1.

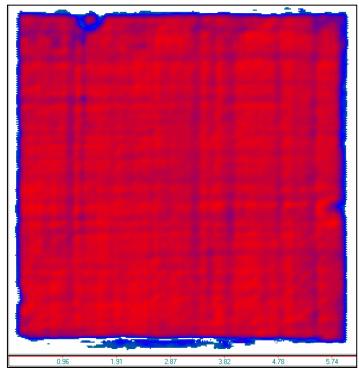
Figure 19. Typical C-scan of flat-plate AlMMC specimen from University of Delaware (sample 112502-1-1).

Most of the plates received from the University of Delaware did not contain any indications that there were significant flaws present. A typical scan of one of these plates is shown in figure 19.

Even though the C-scan is fairly uniform, a faint cross-hatched pattern can be seen that is indicative of the fiber orientations (0 and 90°). A sample with a $\pm 45^{\circ}$ fiber layup is shown in figure 20. The cross-hatching is more pronounced in this sample. However, the return signal was strong, and there was no indication of any serious flaw.

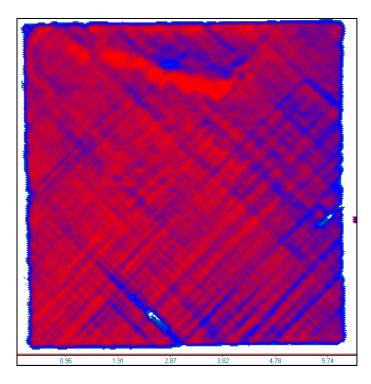
Figure 20. C-scan of sample 121602-2-1 indicating $\pm 45^{\circ}$ fiber layup.

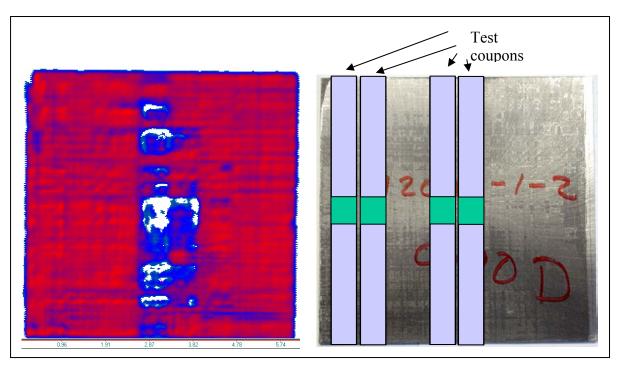
Special attention was paid to those few samples that had indications of flaws. These particular samples were sectioned into coupons that contained the suspect areas in the gage section. An example of this is shown in figure 21 (courtesy of Ian Hall, University of Delaware). Here, a photograph of the sample 112002-1-2 is overlaid with the position and orientation of the test coupons. Included in the figure is the ultrasonic C-scan of the same plate. The white area in the scan is included in the gage sections of the two coupons taken from the middle of the sample.

Figure 21. Comparison of ultrasonic C-scan with coupon location and orientation on sample 112002-1-2 (courtesy of Ian Hall, University of Delaware [Hall, 2003]).

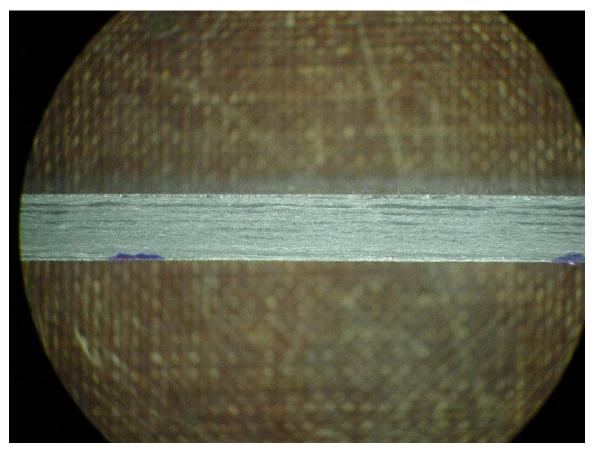
None of the sectioned samples exhibited any crack, delamination, or lack of infusion as was seen in the samples with known defects. Several hundred micrographs of the suspect areas on various samples were taken with no indication of the presence of a gross flaw or defect. A micrograph of the central part of sample 112002-1-2 is shown in figure 22.

Figure 22. Micrograph of internal surface of sample 112002-1-2 (courtesy of Ian Hall, University of Delaware [Hall, 2003]).

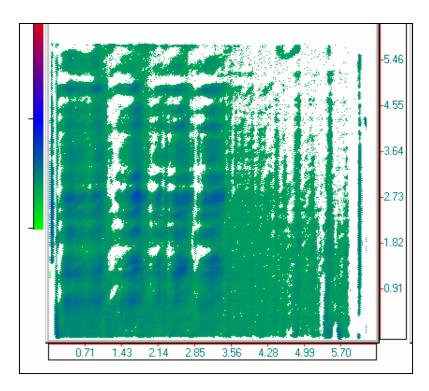
An example of a C-scan showing possible flaws is shown in figure 23. Previous work indicated that a low (or nonexistent) signal return (shown as a white area in the scan) merited further examination. The scan in figure 23 has a large portion that is white. However, this scan was made with a low signal gain (20 dB). An identical scan with a higher signal gain (30 dB) results in the scan shown in figure 24. Here, the fluctuation in return-signal amplitude is similar (but not identical) to that shown in figure 23, but the signal strength is high enough so that no white

Figure 23. C-scan of sample 111902-2-2 showing possible flawed areas (20-dB gain).

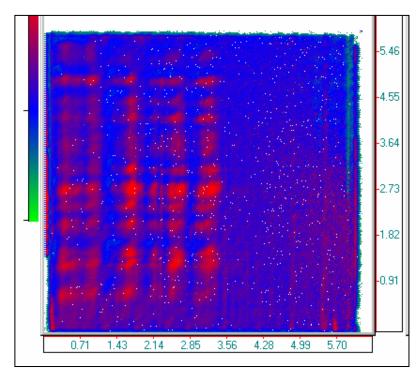
Figure 24. C-scan of sample 111902-2-2 at higher gain (30 dB).

areas appear. These figures are shown to emphasize the point that the C-scans as produced by the Ultrapac equipment show only relative changes in return-signal strength.
